# WOOD DESTROYING PESTS AND ORGANISMS INSPECTION REPORT

Building No. 123	Street Any St.	City San Jose	ZIP 95125	Date of Inspection 07/27/2023	Number of Pages 7
---------------------	-------------------	------------------	--------------	----------------------------------	----------------------

GENERAL DESCRIPTION: One story, wood framed, single family dwelling with wood and stucco exterior.	Inspection Tag Posted: Garage
	Other Tags Posted: Planet Purple Termite Control: 1/1/2023

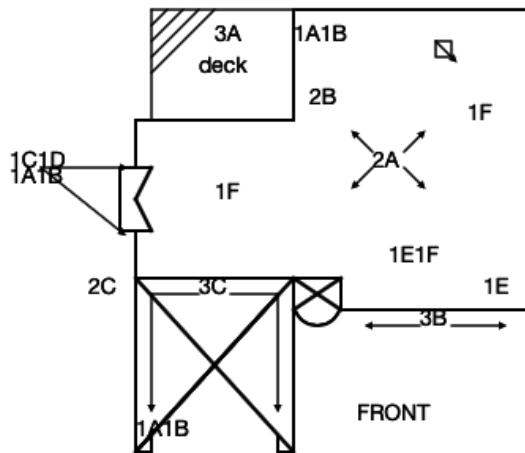
**Diagram Not To Scale**

**FINDING:** Evidence of infestation by drywood termites was noted at the substructure, garage framing and left side eave overhangs (near fireplace), at the approximate locations indicated on the diagram.

**FINDING:** Evidence of infestation by drywood termites was noted at the crawl space, garage and exterior, at the approximate locations indicated on the diagram.

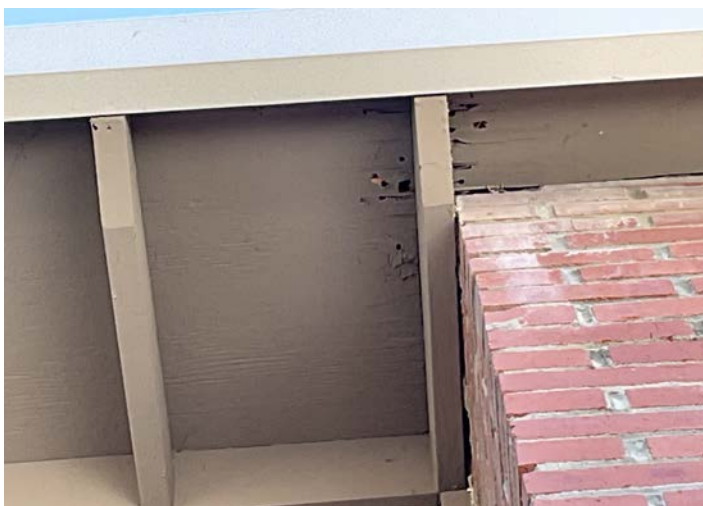
1A,1B,1C,1D

**FINDING:** Fungus damage and drywood termite damage were noted at the eave overhangs (near fireplace). Damage was noted at these specific wood members: plywood roof sheathing.

**FINDING:** Portions of the roof covering must be removed to accommodate roof sheathing repairs, as outlined in the previous item.

**RECOMMENDATION:** Vacate the premises and seal the structure for fumigation with Vikane gas (sulfuryl fluoride), using Chloropicrin as a warning agent. Fumigation is warranted for 3 years (for active infestations by drywood termites). Notice of fumigation must be signed prior to fumigation. See fumigation notice for terms and liabilities. Notes: Total fumigation/ventilation process is approximately 3 days and 2 nights (when scheduled Monday-Thursday, fumigations scheduled over a weekend require additional time). There may be interior and/or exterior preparation work needed to perform the fumigation. Our bid for fumigation may not include preparation work. Innova Termite & Pest Control, Inc. will provide 20 Nylofume bags per fumigation for occupied structures. Additional bags are available for \$2.00 per pair and \$10 for delivery if requested after the initial shipping of the bags. ***Specific exterior fumigator preparation note: There is plant growth at the front of the structure that will need to be trimmed away from the structure in order to fumigate. Our bid does not include trimming plant growth at this area. A professional fumigation preparation company or landscaping maintenance professional should be contracted to perform this work prior to the fumigation. If this plant growth is not cut back, it may be covered during the fumigation and may not survive.***

**SECONDARY RECOMMENDATION IN LIEU OF FUMIGATION:** Drill into and locally treat the visibly infested wood members using a registered termiticide, with foam application method using Alpine (Dinotefuran) or Termidor Foam (Fipronil) and/or Termidor SC (Fipronil). NOTES: Our guarantee for this localized treatment is limited to the treated wood members only for a period of one year from the date of completion. Localized treatment is not intended to be an entire structure treatment method. If infestation by wood destroying pests extend or exist beyond the area(s) of the localized treatment, they may not be exterminated. Interested parties should be aware that localized treatment is to be considered substandard in comparison to fumigation. Our bid does not include any touch up paint that may be needed upon completion.

**RECOMMENDATION:** Remove/vacuum up and/or mask over all accessible drywood termite evidence (fecal pellets or swarmers) upon completion of fumigation or localized treatment.

**RECOMMENDATION:** Remove roof coverings as needed to accommodate repairs. Remove the visibly damaged sections of the roof sheathing, then replace with new materials. Install sistered materials for support at the repaired rafter tails as needed. Note: Our bid includes primer painting the new materials only. Our bid does not include repairing, nor reinstalling the roof covering (see following item). Innova Termite & Pest Control, Inc. can recommend or request a bid from a licensed roofing contractor for the needed roof repair upon request. If any additional repair becomes necessary, a supplemental report would be filed with additional bids.

**RECOMMENDATION:** Engage the services of a licensed roofing contractor to replace or reinstall roof coverings upon completion of the outlined roof sheathing repairs.

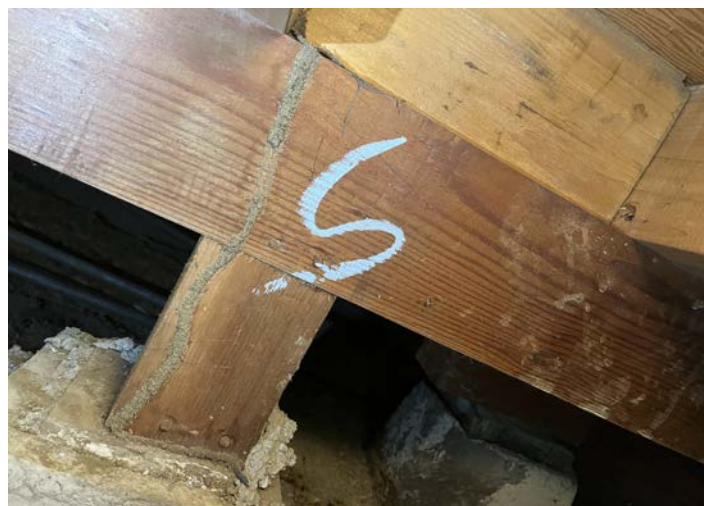
1E

**FINDING:** Evidence of infestations by subterranean termites was noted at the substructure and some of the cellulose debris in the crawl space. The infestations appear to be originating at the crawl space soil and exterior soil.

**RECOMMENDATION:** Perform a guaranteed complete structure treatment for the control of subterranean termites with a registered termiticide (Termidor SC/fipronil). The proposed treatment may include but is not limited to the following treatment methods: Trench, rod and treat subarea/crawl space soil adjacent to all subarea piers, at visibly infested subarea soil areas and exposed soil adjacent to exterior portions of the perimeter foundations. Drill through exterior porches, walkways, patios (where they abut the perimeter foundations) and treat the soil below. Drill through and treat below garage slabs where termite infestation is evident only. Scrape down all accessible evidence of infestation (shelter tubes). Notes: All trenches will be back filled and drill holes will be patched with vinyl plugs and concrete patch. Our guarantee for this proposed treatment is outlined for three years from the date of completion. Innova Termite & Pest Control, Inc. does not guarantee and will not attempt to match any surface to be drilled. Some decorative surfaces may be damaged as a result of drilling (tile, exposed aggregate, colored concrete, painted surfaces, grout, etc.). We will attempt to perform the drilling without damaging any electrical conduit, plumbing, gas lines or other materials that may be concealed below the surfaces to be drilled. If any decking needs to be removed to accommodate treatments, (if infestations are visibly occurring to the structure and entering from a low-profile deck) we will remove and re-install existing decking as practical. Some cosmetic damage may occur as a result of removal. If replacement of deck boards is necessary, additional funds may be required. Interested parties should be aware that Innova Termite & Pest Control, Inc. assumes no responsibility for any damage to concealed electrical, plumbing or gas lines that could occur or any repairs that may be needed as a result of damage. Signing the authorization to perform this item is acknowledgement of these disclaimers.

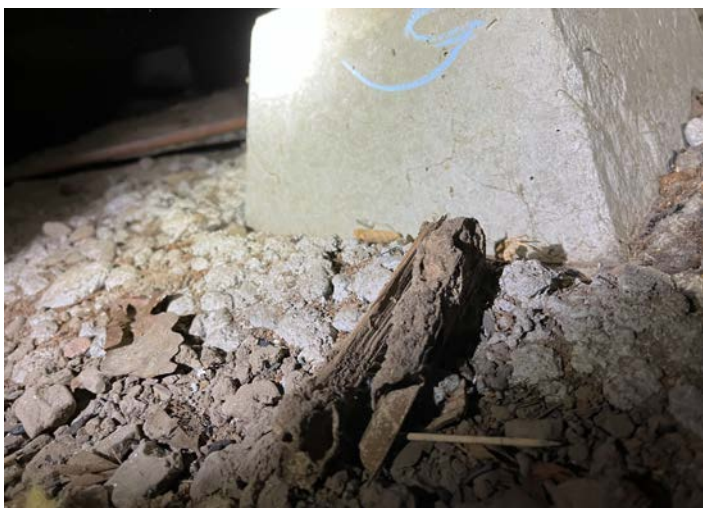
1E,1F

**FINDING:** Evidence of infestation by subterranean termites was noted at some of the cellulose debris, as viewed from the crawl

space.

**RECOMMENDATION:** Remove and dispose of all cellulose debris of a rakeable size or larger.

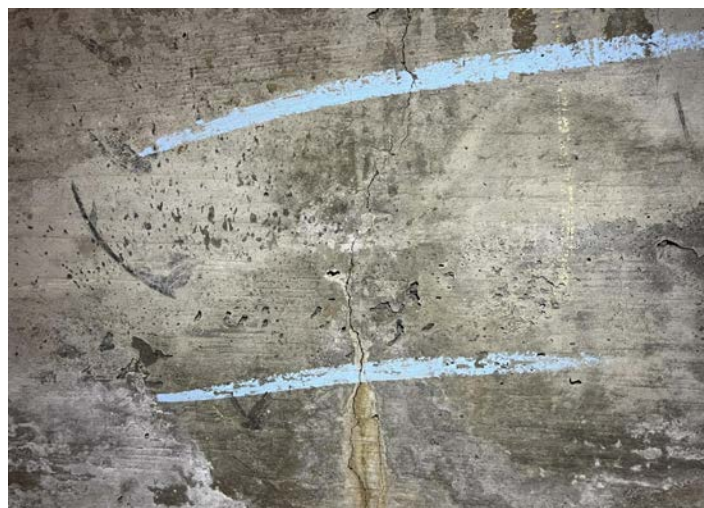
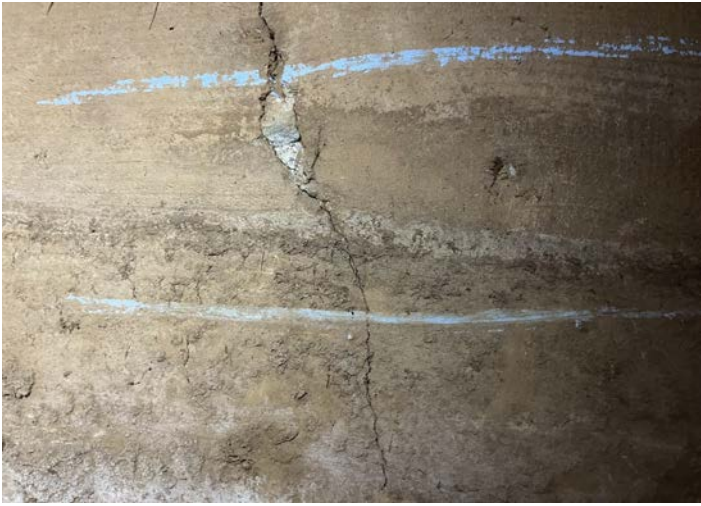
2A

**FINDING:** Some vertical cracks were noted at the foundation (approximately less than 3/16").

**RECOMMENDATION:** Engage the services of the appropriate, licensed tradesperson to check this condition and make any needed corrections.

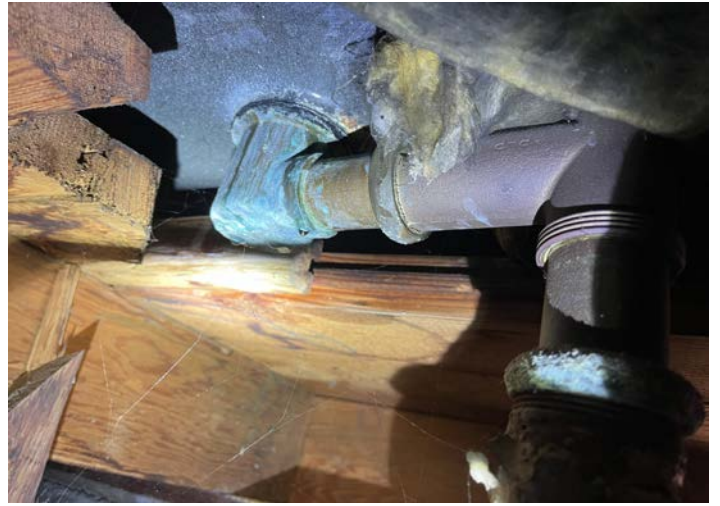
2B

**FINDING:** Leaks were noted at the hall bathroom tub drain, as viewed from the crawl space.

**RECOMMENDATION:** Engage the services of a licensed plumbing contractor to repair the leaks.
